Using the new G.C. Laser Cleaning System for cleaning and surface preparation for re-gilding of a large outdoor bronze monument of Alexander Hamilton

Andrzej Dajnowski^{1*}, Bartosz A. Dajnowski^{1,2}

¹ CSOS Inc., 900 S. Des Plaines Ave, Forest Park, IL 60130, USA

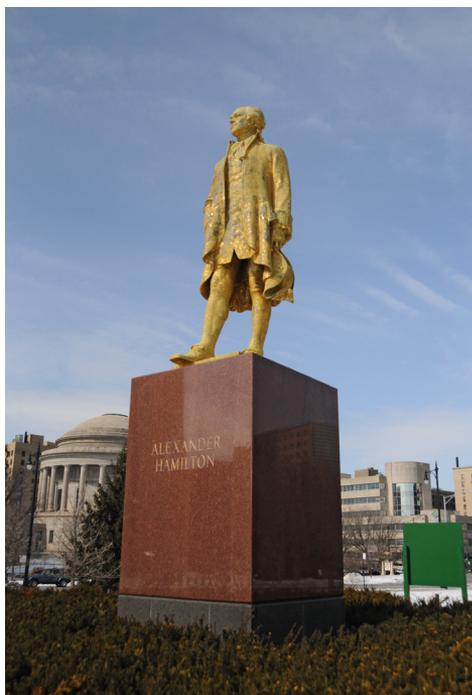
Fig. 1. Hamilton Monument before treatment (Lincoln Park, Chicago).

the time caused the delay of the installation. Although the sculpture was finished in clay in 1939 and cast in 1940, it was not installed until 1952 [1, 2]. It is recognized that the sculpture was re-gilded in 1983 and within a decade the new re-gilding application had severely failed. The intent for this sculpture's appearance is for it to be gold, so its deteriorated condition was not acceptable.

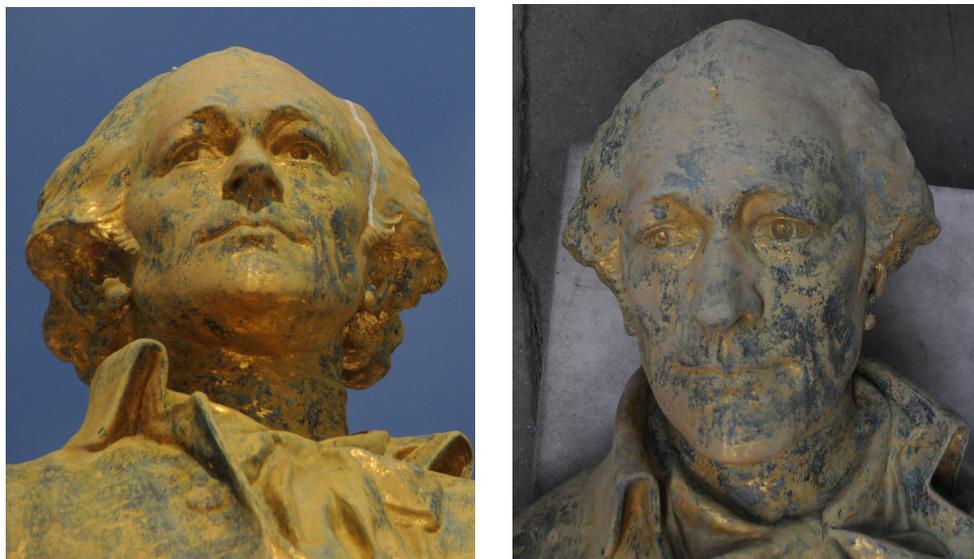
When examined from distance on a sunny day in 2015, the monument of Alexander Hamilton appeared to be golden in color. However, the yellow tone of the sculpture was not actual gold, but rather yellow due to the yellow zinc primer that covered the surface. The 3.91 meter tall, 1,587 kg bronze was heavily corroded and most of the gilding was missing. Furthermore, the corrosion was masked by the bright yellow tone of the primer and the reflection of the remaining traces of gold.

Fig. 2. Detail of the face. Left image taken on a sunny day while the sculpture was still in the park and the image on the right taken indoors without the presence of direct sunlight.

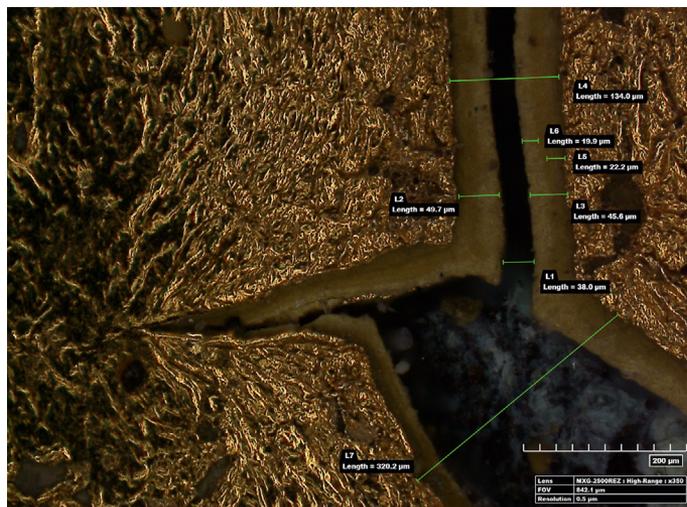
Figure 3 shows the surface of the deteriorated gilding and active corrosion products. The area photographed is approximately 1.0 mm wide. The gold and primer are cracked and separated from the actively corroding metal substrate.

Fig. 3. 3D Micrograph illustrating the deterioration of the gilding and active corrosion.

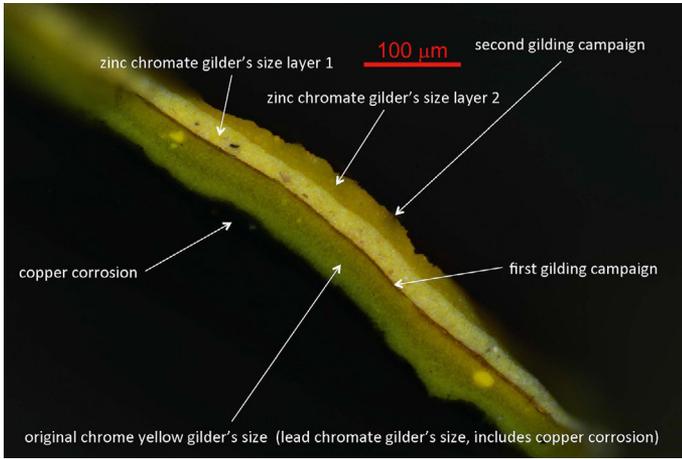
dence that the gilding performed in 1983 was done without complete corrosion removal and without complete removal of the old primer. According to the historical information, the sculpture was “cleaned for one week by two workers” [2]. First of all, the surface was likely washed and mechanically cleaned. Secondly, the new zinc chromate primer was applied in two layers on top of the old gilding and then the surface of the bronze was re-gilded. This kind of surface preparation is not sufficient for the treatment of an outdoor sculpture that is to be gilded and exposed to Chicago weather. If the sculpture was kept in a controlled indoor environment, then perhaps the re-gilding would have survived in better condition. In the case of outdoor

primer separated by a layer of gold in the middle. The top of the cross-section (Fig. 4) shows small areas of gold that was preserved on the top of the original primer. The dark bottom layer (under the primer) was composed typically of the green corrosion that was found in all of our samples. This sample illustrates that corrosion was undercutting the gold and primer layers. It provides evi-

Fig. 4. Cross-section microscopy image of a sample of the gilding where layers from different gilding campaigns are visible (prepared by J. Mass and A. Finnefrock).

lems on a surface is ultimately irresponsible. The removal of all corrosion products [3] and the deteriorated primer to a completely clean bronze surface was the only way to ensure a stable foundation onto which new gilding could be applied to last for decades. It must be noted that all aspects of this project were discussed with the owner. The importance of using laser ablation for this project was significant, because it allowed conservators to safely remove all surface deposits without disturbing surface topography of the bronze [4]. In particular, the G.C. Laser systems used for this project allowed for precise control over parameters and efficient cleaning of this large bronze.

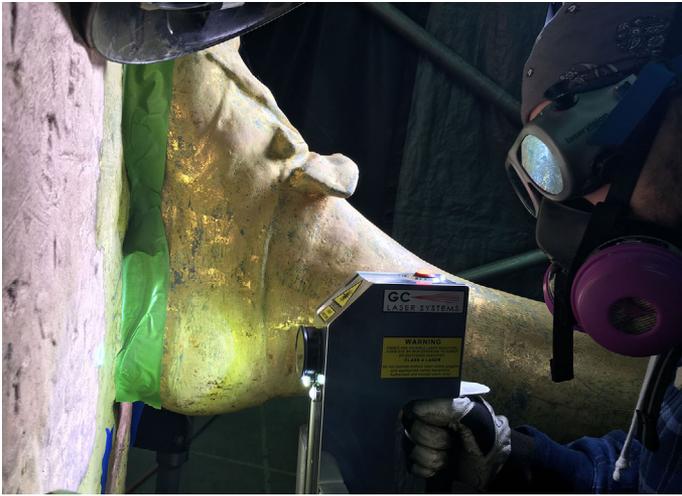
Fig. 5. Laser cleaning of the bronze surface performed by CSOS laser technician Christopher Ciaston. The laser has built-in lights to illuminate the workspace. An extraction trunk at the top left of the image is collecting fumes.

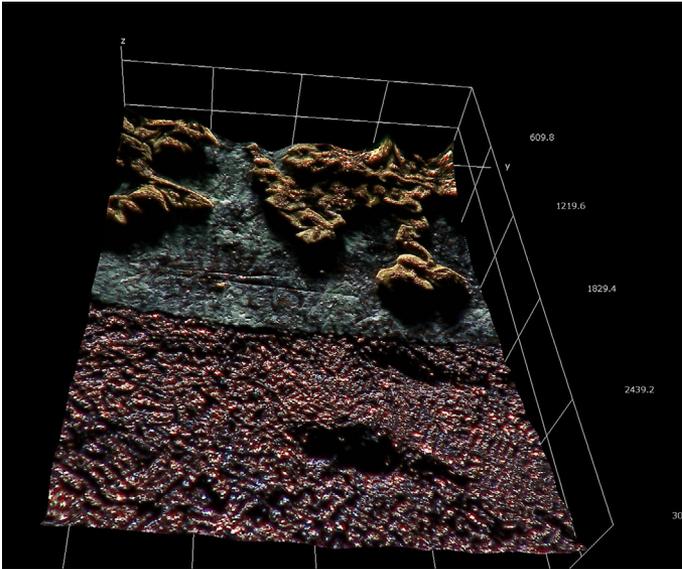
Fig. 6. Laser cleaning is able to remove old gilding, primer, and active corrosion products from the surface and uncover the dendritic structure of the bronze surface. Dimensions of examined area are: depth 3.05mm and width 2.29 mm.

Examination with a Hirox 3D microscope shows that the laser effectively removes failed gilding, old primer, and corrosion products to uncover the original dendritic crystal features of the bronze surface. Some of this dendritic pattern is visible in the green corrosion, but

after laser cleaning it is very clearly uncovered. The laser is able to clean the surface without damaging the dendritic features of the original metal. A layer of cuprite can also be preserved.

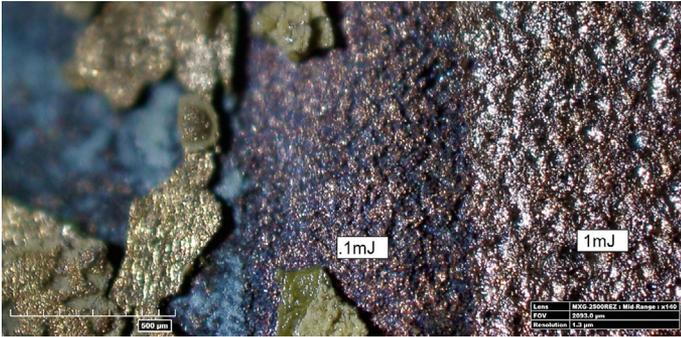
During testing it was established that a 100 ns pulse with a pulse energy of 0.1 mJ and fluence of around 0.5-1.5 J/cm² removed the surface corrosion down to

Fig. 7. Image illustrating the surface before laser cleaning on the left, the surface cleaned with 0.1mJ pulses in the middle and 1mJ pulses on the right.

a cuprite layer, but did not always remove all of the primer and gold material. In order to ensure all active corrosion products were removed, 100ns-250ns pulses with a higher pulse energy of 1mJ per pulse were used at a fluence range of 3-5.5 J/cm². Various optics were used to reach different focal depths with an in focus spot size of 200 microns with a pulse frequency ranging from 50 kHz-300 kHz, depending on the area being cleaned and the size of the scan. Because this sculp-

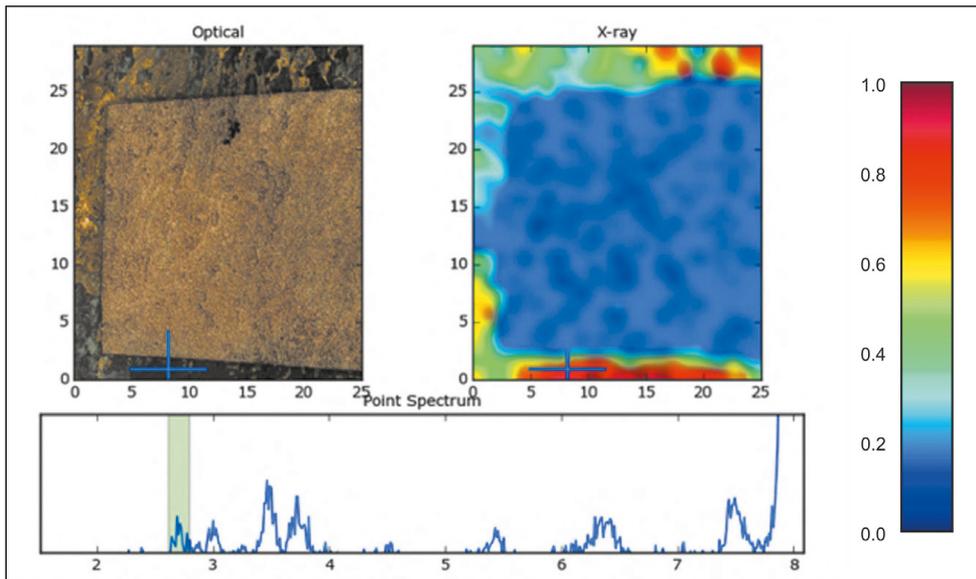
ture was going to be painted with a primer, it was desirable to clean down to a pure raw bronze surface to ensure that all corrosion products were removed. Examination with an Elio Portable XRF showed that chlorides were effectively removed from the laser cleaned area (Fig. 8).

The XRF was used to generate a false color map for chlorine and the laser cleaned square section is cool blue, indicating that chlorine is not present.

Fig. 8. Elio XRF chlorine distribution shown as a false color map. The laser cleaned area is cool blue, indicating low concentration of chlorine (image by N. Barbi).

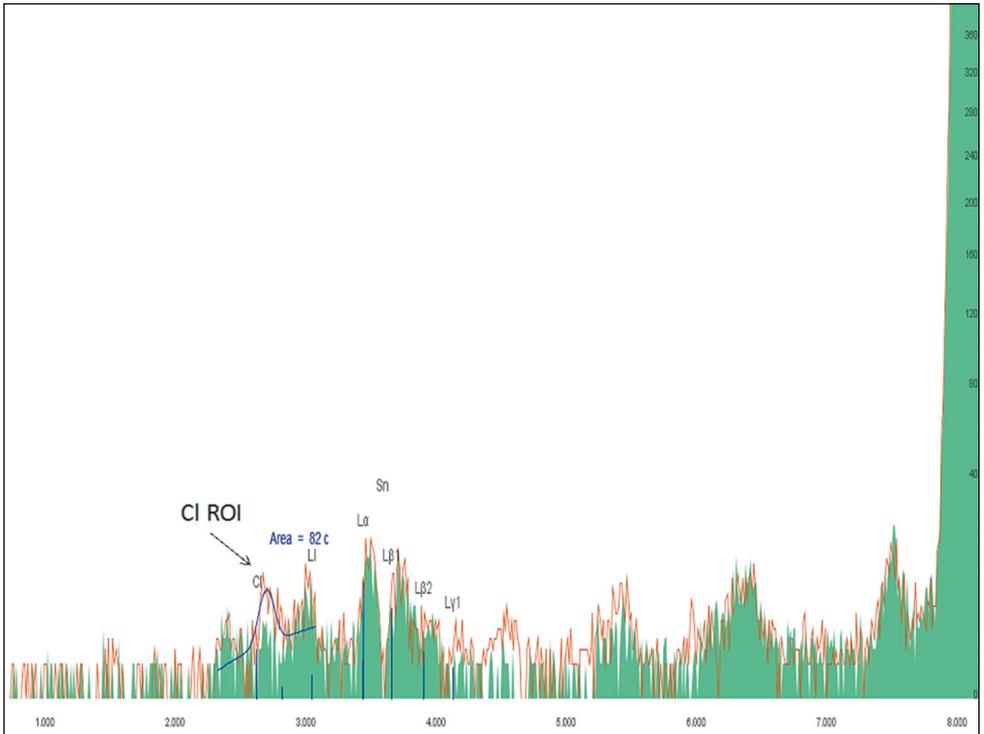
Fig. 9. Identification of chlorine by Elio XRF. The red spectrum is from the red region in the map and the green spectrum is from the blue region in the map in Fig. 8 (N. Barbi).

Each region of interest (ROI) in the XRF spectrum (Fig. 9) was mapped according to the false color scale: the red represents areas of the maximum intensity and blue represents the minimum intensity of the Cl signal. The scales of axes of images are given in millimeters. In the spectrum in Fig. 9 the horizontal axis scale is expressed in keV, and the vertical axis is intensity. The intensity at the 100% value corresponds to 30 counts. Each spectrum was collected for 1 second (operator selected).

picking out the overall patterns. This pattern recognition skill of the human brain is one reason maps are so powerful. Fig. 9 illustrates 1-second spectra, one from a red area in the map (high intensity) and one from a blue area (low intensity). The difference in the Cl ROI can be readily seen. The fitting calculates a peak integral of 82 counts, the square root of which is about 9, with a sigma of 11% (N. Barbi). The data indicates that chlorides have been successfully removed by the laser cleaning process.

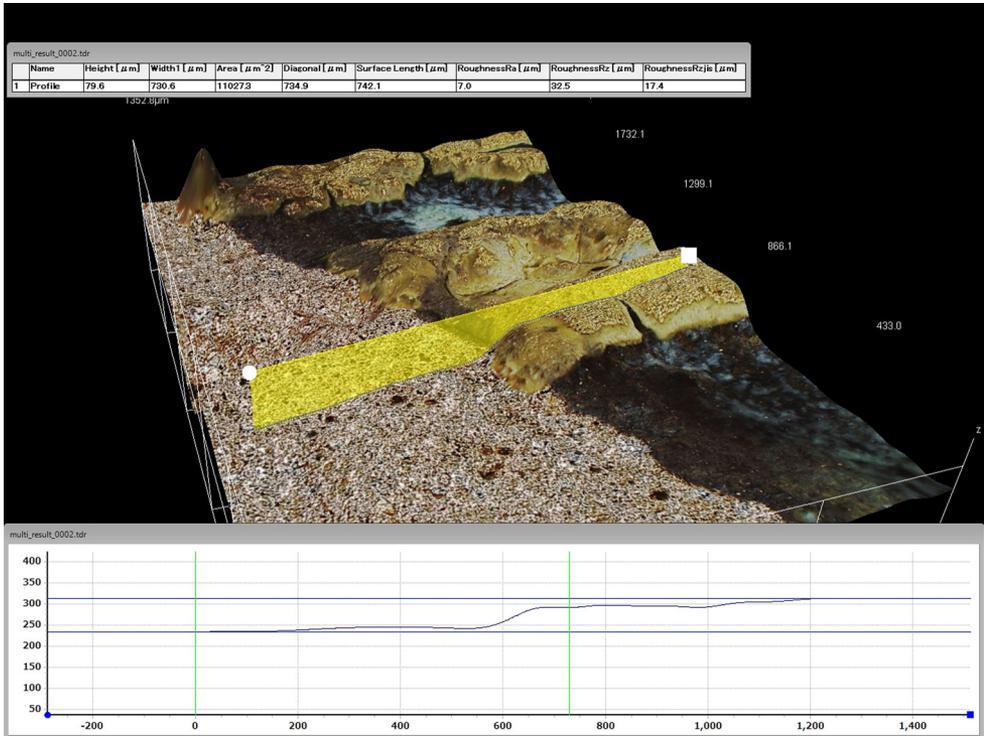
The upper portion of Fig. 10. presents 3D image of the area cleaned with laser. The lower diagram shows surface topography of the cleaned metal. It should be noted that there are no topographic changes in the cleaned zone. The above image illustrates that

Fig. 10. Hirox 3D depth profile of the laser cleaned area shows that approximately 50 microns of corrosion and old gilding are removed by the laser.

it is possible to remove the corrosion products using laser ablation process and keep the original surface intact. In addition, the profile shows that after laser cleaning there was no change in the surface topography.

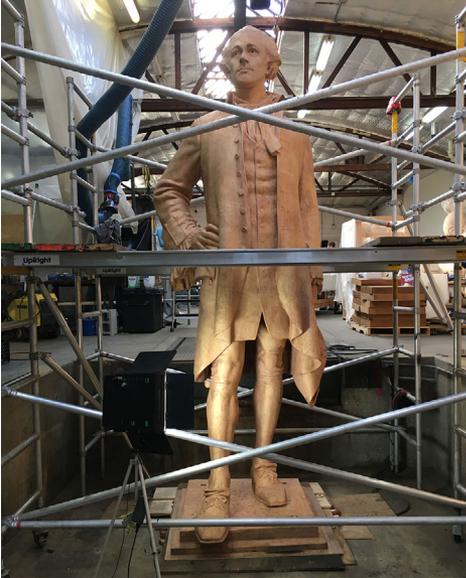
Fig. 11. Hamilton Monument entirely cleaned of the surface corrosion with the use of the laser ablation process.

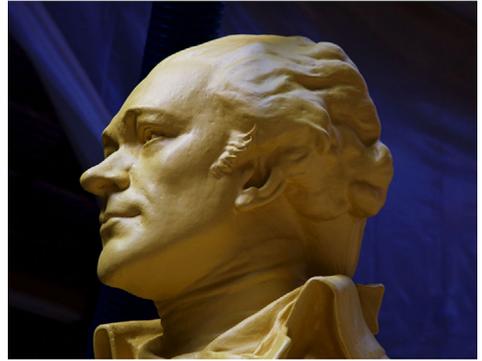
Fig. 12. Face of the sculpture after coating with zinc chromate.

The sculpture after laser cleaning was degreased with the use of acetone and ethyl alcohol. Two coats of epoxy based zinc chromate primer manufactured by PPG were applied to the entire surface of the sculpture.

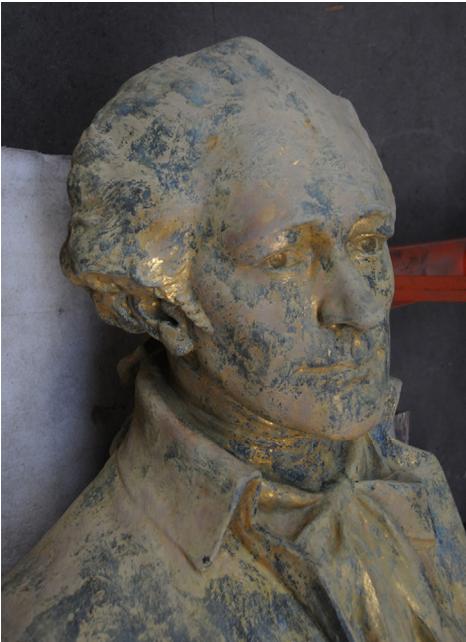
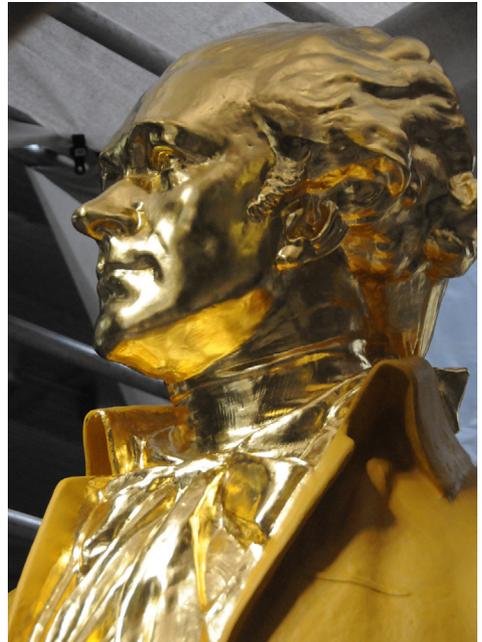
Fig. 13. On the left – the image of the sculpture before treatment, on the right – gilded face and chest of the figure. The jacket is primed before gilding.

The primer was allowed to cure for five days and 12 hour Lefranc oil size was applied to the areas that were going to be gilded. Rosanobel double thickness 23.75 karat gold was used for gilding the monument. The head, shoulders, base and upper surfaces of the sculpture were gilded twice. The application of second layer of gold to those areas will provide longer lasting protection for the surface of the bronze.

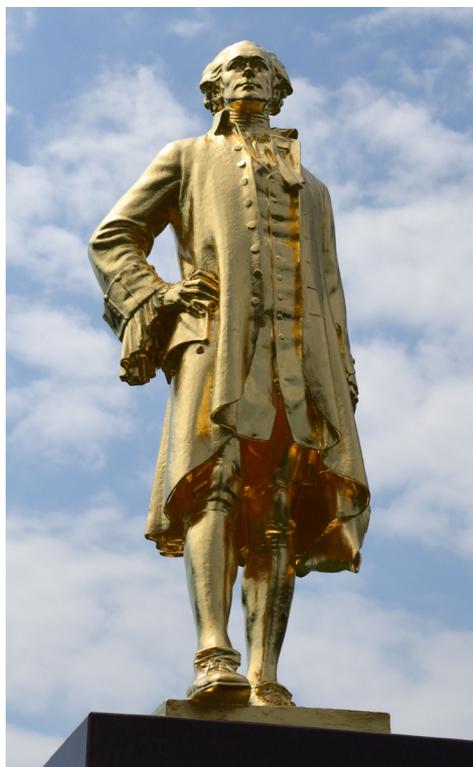
Fig. 14. Hamilton sculpture after gilding reinstalled in Lincoln Park.
