## Laser-based techniques for a multidisciplinary action aimed at the restitutive restoration of S. Costanzo church in Ronciglione (Italy)

In the framework of the COBRA (Conservation of Cultural Heritage through Radiation and Enabling Technologies) project a multidisciplinary study was carried out in order to restore the mural painting of the dome of the S. Costanzo church in Ronciglione (Italy). Large difficulties were met during the restitutive restoration of the original renaissance fresco decorating the dome, patronized by the Italian Ministry of Cultural Heritage (SABAP RM MET). In fact, two and sometimes three layers of paint, which lays on an extremely crumbled substrate were detected on the surface, in addition to large, deep and complex degradation forms with the presence of efflorescence. To solve such a critical situation, researchers, conservators and laser cleaning system suppliers collaborated to plan the most appropriate intervention. Laser-based diagnostics were employed to characterize different areas of the fresco surface before and after cleaning tests. In particular, ENEA offered its prototypes of LIF (Laser Induced Fluorescence) and RGB-ITR (Red Green Blue Ima

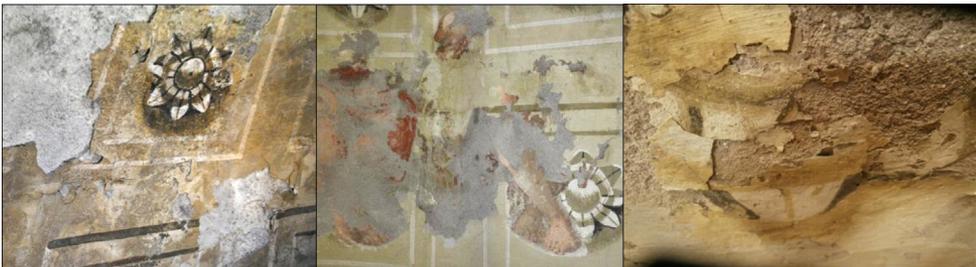
Fig. 1. Deterioration of decorate surface of the dome.

Historical documentation traces the church's origin back to the 16<sup>th</sup> century. During its lifetime, the decorative setting has gone through many changes, and the current general appearance spans from the baroque style of the altar to the neoclassic one of the nave. The dome shared its fate: the ongoing restoration work is showing the visible coffered decoration of the 18<sup>th</sup> century, concealing other more ancient decorations. A long history of infiltration and carelessness had produced several damages such as the decay of mortar, accretions, brittleness, losses and flaking. The paintings appeared to be in very poor condition, but yet several different and fine decorative pieces were still visible. An earlier overview highlighted the presence of two/three layers of paint, irregularly overlapped one to each other, laying on a plaster substrate extremely disaggregated and with the presence of efflorescence. In Fig. 1 examples of the deteriorated surfaces are presented.

On a disaggregated mortar, filled with soluble salt deposits and altered materials due to past infiltrations, there was a fresco with a glory of angels, of very fine manufacture, yet highly damaged and overpainted. It presented painting holes, *secco* paintings

and strong decohesion. On such layer, there was a polychromy at lacunars motif, painted without any preparatory layer and engraving the decorative pattern directly on the fresco layer. In some areas, there was a third layer having another polychromy with the same lacunar motif of underlying layer. The degradation of the polychrome multi-layer was so dramatic that it could not sustain neither the pressure of a lancet nor the weight of a compress. Then, issues encountered in consolidation, in identification of biodeteriogens and of different pictorial techniques that were used required accurate investigations and the use of the least invasive techniques. Moreover, due to the large quantity of areas to be evaluated rapidly (see Fig. 2), fast imaging techniques were preferred in order to reduce the time of the analysis.

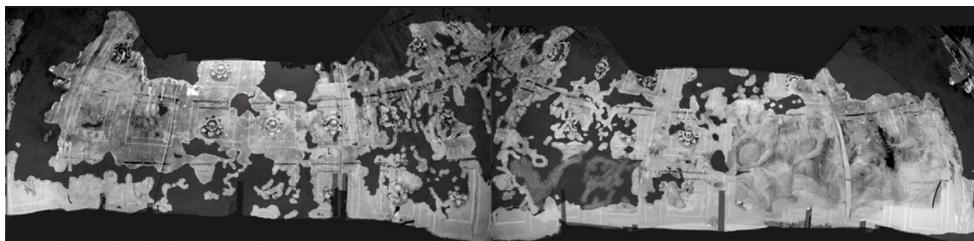
Fig. 2. The 360° view of the dome showing the major intervention areas (in light gray). The circumference at 80 cm is 14 m. The total dome area is 37 m<sup>2</sup> of which 22 m<sup>2</sup> with painting remains.

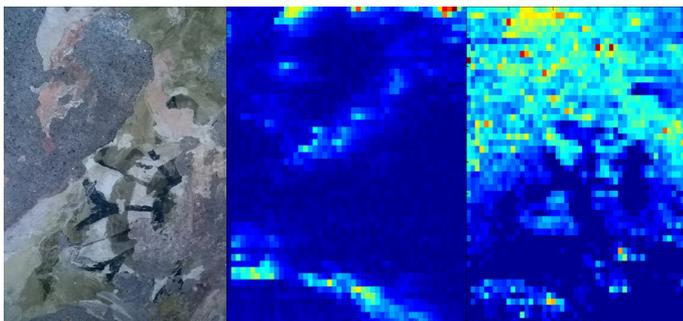
Fig. 3. An area examined by LIF: standard image in visible range (left), fluorescence map at 300 nm, indicative of acrylic consolidants (centre), fluorescence map at 700 nm, indicative of photosynthetic microorganisms (right). In the maps the colour is from blue for low intensities to red for higher intensities at the selected wavelength.

of about 1 cm. This value is a compromise between the need of shortening acquisition times and those of providing answers to the specific questions asked by conservators. All collected spectra were processed and used to build fluorescence images, as the ones shown in Fig. 3. To generate every image, spectral data were filtered at the selected wavelength and normalized by the maximum obtained at such wavelength on the whole scan. In particular, in Fig. 3, fluorescence images at 300 nm and 700 nm are reported. They are of great importance because they are indicative of the presence of acrylic consolidants on the one hand and of photosynthetic microorganisms on the other, according to literature [8] and a database prepared thanks to laboratory research conducted on known samples. In this way, characteristics not visible by naked eye were highlighted. The obtained results confirmed the presence of preferential migration directions for consolidants injected in the surface for the consolidation action (Fig.3, centre), providing detailed maps which can help conservators in the evaluation of the consolidation technique.

The fluorescence spectra of the whole surface are dominated by the presence of large bands centred at 450 nm and 500 nm due to the presence of  $\text{CaCO}_3$  and  $\text{CaSO}_4$ . No signals that can be referred to organic

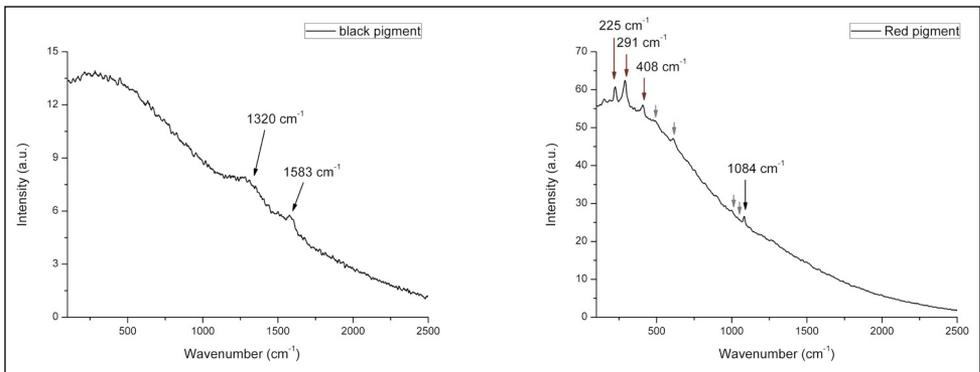
**Fig. 4.** Raman spectra for: black pigment in the outer layers (left) and for red pigment in the original fresco (right). In the latter Raman lines from calcite (at  $1084\text{ cm}^{-1}$ ), red ochre (at  $225, 291, 408\text{ cm}^{-1}$ ) [13] and  $\text{CaSO}_4 \times \text{H}_2\text{O}$  ( $492, 621, 1007, \text{ and } 1135\text{ cm}^{-1}$ ) are clearly visible.

binders, in agreement with a database built in laboratory from known samples prepared according to Cennino Cennini's recipes [9], were found on the surface. This observation would exclude the use of a *tempera* technique for the repainting of the dome, but rather it would suggest the use of lime painting. These results were confirmed by Raman spectroscopy, which allowed to recognize pigments and constituent materials. In the outer layers in the dark spots a black carbonaceous pigment from animal sources (ivory black or/and bone black) was individuated (Fig. 4 left) [10]. In the original fresco in red and pink areas, red ochre, mixed with  $\text{CaCO}_3$  and  $\text{CaSO}_4 \times 2\text{H}_2\text{O}$  was found (Fig. 4 right). Moreover, characteristic signals from calcium carbonate and sulphate were found on the whole surface without any signals that could be assigned to organic binders, in the limits of detections of the specific instrument used. In fact, spectral bands that can be assigned to aliphatic modes (near  $3000\text{ cm}^{-1}$  and between  $900$  and  $1500\text{ cm}^{-1}$ ) or to carboxylic group and unsaturations ( $1600$ – $1800\text{ cm}^{-1}$  region) typical of most common historical binding media (fresh and aged) were not detected [11, 12].

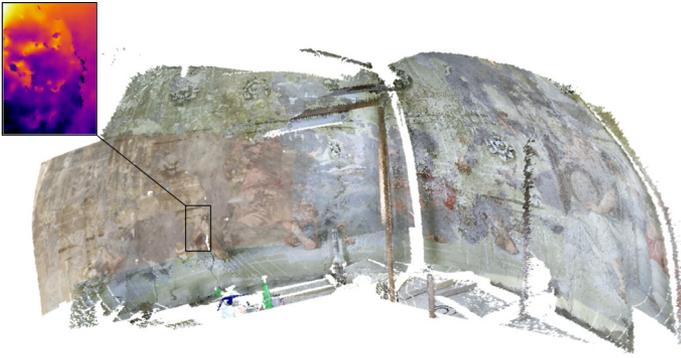
Fig. 5. on the left RGB-ITR scan (on the west sector of the dome) on the first tests with a new prototype, COBRAKIN. In the box a thermogram with a highlighted detachment area in white-yellow.

The RGB-ITR was used for digitalizing before and after the laser cleaning intervention. This kind of digitalization had a dual purpose: the first was to have a historical memory of the drawings before the cleaning of the surface, the second to have two 3D multispectral maps of the interested areas for a semi-automatic detection of possible colour or structural modifications caused by the laser-cleaning intervention. This result was obtained by superimposing the data collected by different instruments (like LIF, RAMAN and thermography) on RGB-ITR 3D colorimetric meshes. The RGB-ITR was tested only on a limited portion of the dome: the rest of the structure was digitalized by the use of a low-cost structured light sensor called COBRAKIN. This latter sensor is also able to collect high definition photos by the use of a standard camera: this information was affected by the environmental lights, because it was impossible to create a photographic light setup. For calibrating these images the RGB-ITR colorimetric information will be used. An example of the images obtained is presented in Fig. 5. In this figure, a thermogram of a selected area (in the black box) is presented, too. Thermog-

raphy revealed widespread detachments of the painted areas of the dome. They can be attributable to phenomena of crystallization of the soluble salts due to the presence of rainwater and/or the biological attack. The presence of overlapping layers of paint could triggered widespread detachments of the surface layers. External materials coming out from previous restorations can be the reason for the final degradation state. The images of the upper dome levels showed very critical conservation conditions due to rain water infiltration (Fig. 6).

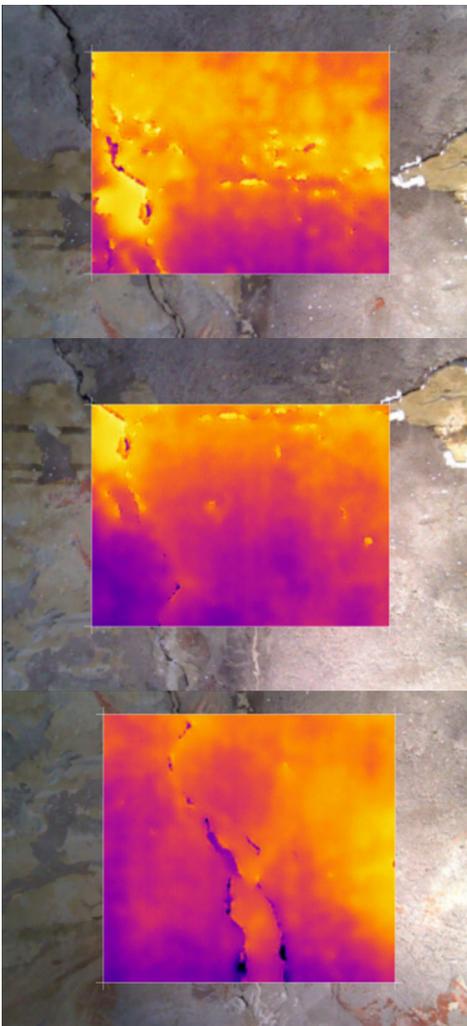
← Fig. 6. Results of thermovision on the west sector, same area analysed by LIF and presented in Fig. 3.

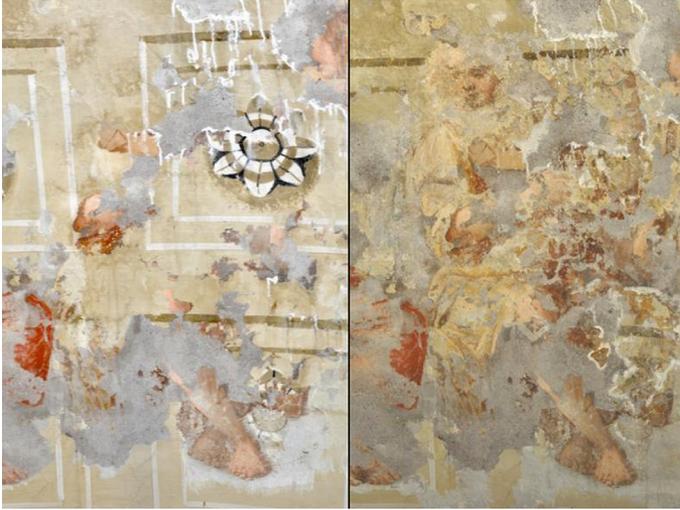
Fig. 7. Before (left) and after (right) the application of laser cleaning.

The successful outcomes of the laser cleaning are mainly due to a secondary spallation effect that allowed to remove micro-portions of the outer layers with high accuracy. An example of the obtained results is shown in Fig. 7. Here the same area of the dome before (left) and after (right) the laser cleaning is

shown. As it is possible to notice on the left, originally a lacunar damaged motif is present and just some fragments of a human figure are visible (mainly feet at the bottom of the picture). The laser cleaning allowed discovering a whole cantor angel (clearly visible in the picture on the right). Thanks to this painstaking cleaning work several angel figures of good quality emerged.
